KINGSTON SOLAR PROJECT, NR GOTHAM NOTTINGHAMSHIRE

Mining Risk Assessment

Prepared for: RES UK Ltd

SLR Ref No: 405.02606.00051

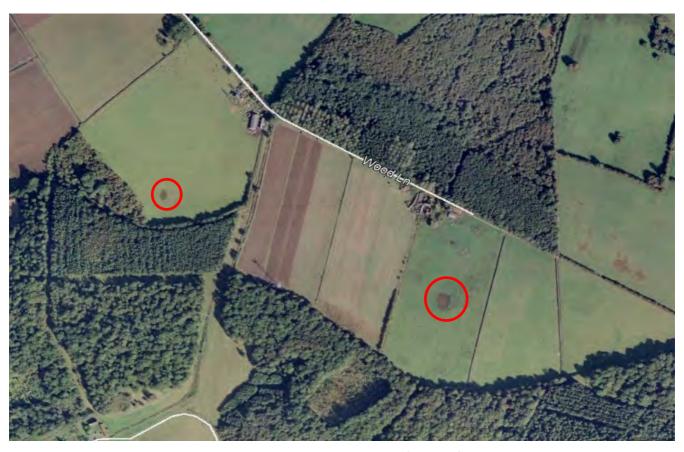
unpredictable, however the risk to the project is low as it is very localised. The impact to the site has been very minor, and the likelihood is that minor settlement of solar panels could be managed through minor adjustment and relevelling of the solar panels should subsidence occur. Should localised subsidence occur it would impact on a limited scale to the project and would not have a major financial or strategic impact. It would be recommended that any of the sensitive infrastructure items (i.e., the invertors and substation) should be located away from these areas.

Areas of localised subsidence in Areas 1/7 and 1/10 in 2001

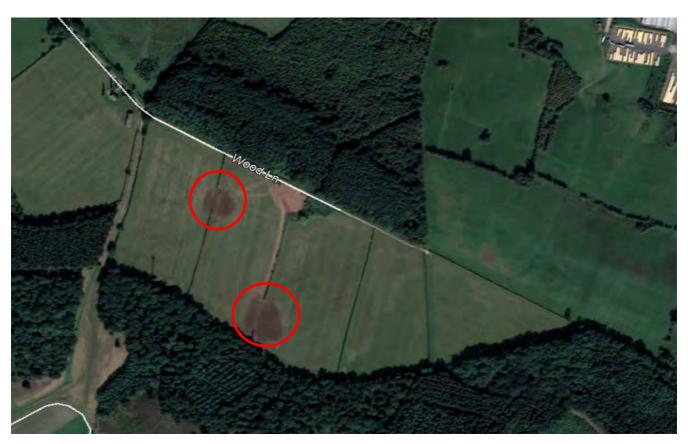
Areas of localised subsidence in Areas 1/8,9 and 1/10 2013

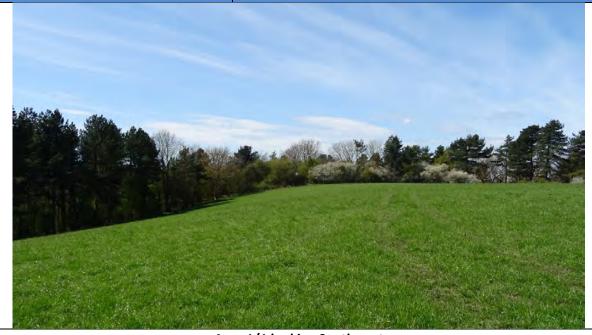
Area 1/1 looking Southwest

Site Location	Area 1/1
Current Use	Agriculture - arable
Slope	Mainly flat lying with steeper slope (>10%) to south over
	25% of site
Soil type	Slightly clayey soils
Geology	Triassic calcareous mudstones of the Barnstone Member,
	overlying the Cotham Member, the Westbury Formation
	and the Blue Anchor Formation (gypsum)
Depth to bedrock	2m
Existing constraints	Avoid >10% slope to the south
Services	None
Evidence of Historic Mine Workings	Kingston Mine entrance to south
Depth to workings	>50m
Age of workings	1985-90, limited older workings in extreme southeastern
	corner
Mining Void	2.5 m maximum
Void to Rock Ratio	>10:1
Type of Workings	Pillar and Room regular design
Evidence of subsidence	None evident, slight erosion on south facing slope, not
	necessarily mining related
Mining Risk to Solar Farm	Negligible
Mining Risk to Infrastructure	Negligible
Is site suitable for solar panels	Yes, on flatter area to the north

Is site suitable for infrastructure	Yes, on flatter area to the north
OVERALL MINING RISK	NEGLIGIBLE

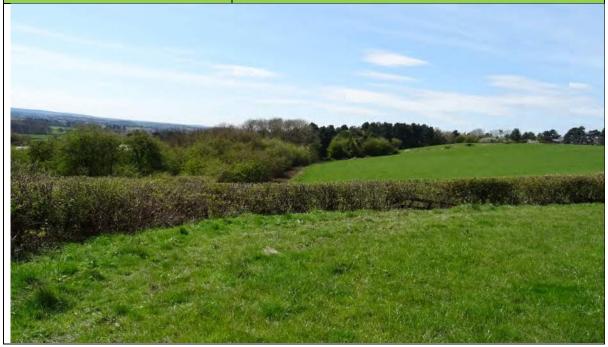
Area 1/2 looking West

Site Location	Area 1 /2
Current Use	Agriculture - arable
Slope	Mainly flat lying with steeper slope (>10%) to south over 33% of site
Soil type	Slightly clayey soils
Geology	Triassic calcareous mudstones of the Barnstone Member, overlying the Cotham Member, the Westbury Formation and the Blue Anchor Formation (gypsum)
Depth to bedrock	2m
Existing constraints	Avoid >10% slope to the south
Services	None
Evidence of Historic Mine Workings	Kingston Mine entrance to south
Depth to workings	60m dropping to around 40m to south of site
Age of workings	1985-90, older workings in south of site 1900-1940
Mining Void	2.5 m maximum
Void to Rock Ratio	>10:1
Type of Workings	Pillar and Room regular design except for small area of older workings
Evidence of subsidence	None evident
Mining Risk to Solar Farm	Low
Mining Risk to Infrastructure	Low
Is site suitable for solar panels	Yes, on flatter area to the north
Is site suitable for infrastructure	Yes, on flatter area to the north

OVERALL MINING RISK	NEGLIGIBLE TO LOW

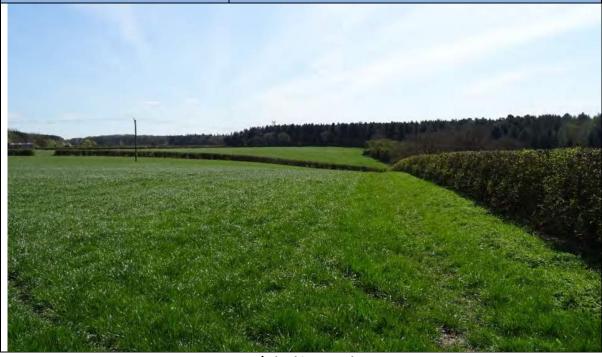
Area 1/3 looking Northeast

Site Location	Area 1/3
Current Use	Agriculture - arable
Slope	Mainly flat lying with steeper slope (>10%) to south over
	10% of site
Soil type	Slightly clayey soils
Geology	Triassic calcareous mudstones of the Barnstone Member,
	overlying the Cotham Member, the Westbury Formation
	and the Blue Anchor Formation (gypsum)
Depth to bedrock	2-3m
Existing constraints	Avoid >10% slope to the southwest corner
Services	
Evidence of Historic Mine Workings	Kingston Mine entrance to south
Depth to workings	>60m
Age of workings	1985-90, limited older workings in extreme southwest of
	site
Mining Void	2.5 m maximum
Void to Rock Ratio	>10:1
Type of Workings	Pillar and Room regular design except for very small area of
	older workings
Evidence of subsidence	None evident
Mining Risk to Solar Farm	Negligible
Mining Risk to Infrastructure	Negligible
Is site suitable for solar panels	Yes, on flatter area to the north
Is site suitable for infrastructure	Yes, on flatter area to the north

OVERALL MINING RISK	NEGLIGIBLE

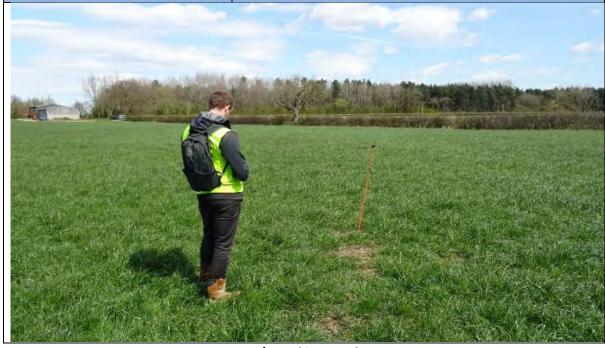
Area 1/5 Looking Northeast

Site Location	Area 1/5
Current Use	Agriculture - arable
Slope	Mainly flat lying over entire site
Soil type	Slightly clayey soils
Geology	Triassic calcareous mudstones of the Barnstone Member, overlying the Cotham Member, the Westbury Formation
	and the Blue Anchor Formation (gypsum)
Depth to bedrock	2-3m
Existing constraints	Older abandoned workings to the north, very limited area
Services	None
Evidence of Historic Mine Workings	Winsers Mine to the north
Depth to workings	>50m
Age of workings	1985-90, limited older workings in extreme north of site
	(1896) from Winsers Mine
Mining Void	2.5 m maximum
Void to Rock Ratio	>10:1
Type of Workings	Pillar and Room regular design
Evidence of subsidence	None evident
Mining Risk to Solar Farm	Negligible
Mining Risk to Infrastructure	Negligible
Is site suitable for solar panels	Yes, on flatter area to the north
Is site suitable for infrastructure	Yes, on flatter area to the north

OVERALL MINING RISK	NEGLIGIBLE

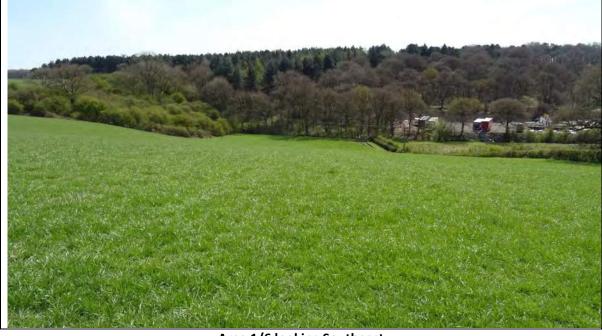
Area 1/6 looking Southeast

Site Location	Area 1/6
Current Use	Agriculture - arable
Slope	Mainly flat lying with steeper slope (>10%) to south over
	80% of site
Soil type	Slightly clayey soils
Geology	Triassic calcareous mudstones of the Barnstone Member,
	overlying the Cotham Member, the Westbury Formation
	and the Blue Anchor Formation (gypsum)
Depth to bedrock	2-3m
Existing constraints	Slope to the south >10%
Services	None
Evidence of Historic Mine Workings	Kingston Mine entrance to south
Depth to workings	>50m dropping to around 40m to south of site
Age of workings	1985-90, limited older workings in extreme southwest of
	site
Mining Void	2.5 m maximum
Void to Rock Ratio	>10:1
Type of Workings	Pillar and Room regular design except for small area of
	older workings
Evidence of subsidence	None evident
Mining Risk to Solar Farm	Negligible
Mining Risk to Infrastructure	Negligible
Is site suitable for solar panels	No too steep
Is site suitable for infrastructure	No too steep

OVERALL MINING RISK	NEGLIGIBLE

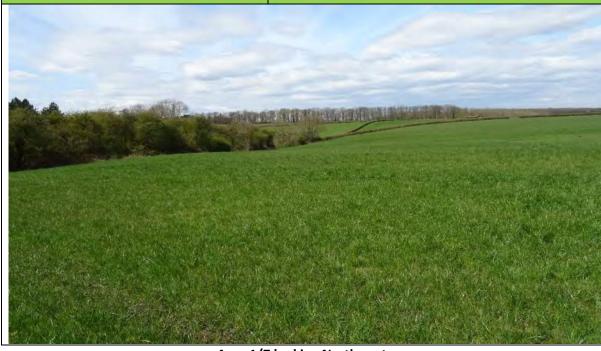
Area 1/7 looking Northwest

Site Location	Area 1/7
Current Use	Agriculture - arable
Slope	Mainly flat lying over entire site
Soil type	Slightly clayey soils
Geology	Triassic calcareous mudstones of the Barnstone
	Member, overlying the Cotham Member, the
	Westbury Formation and the Blue Anchor Formation
	(gypsum)
Depth to bedrock	2-3m
Existing constraints	Localised subsidence
Services	None
Evidence of Historic Mine Workings	Kingston Mine entrance to west
Depth to workings	60m dropping to around 40m to south of site
Age of workings	1985-90, older workings in south of site 1900-1940
Mining Void	2.5 m maximum
Void to Rock Ratio	>10:1
Type of Workings	Pillar and Room regular design except for small area
	of older workings
Evidence of subsidence	Some evidence of subsidence in southern portion
	over older workings
Mining Risk to Solar Farm	Medium but only in localised area
Mining Risk to Infrastructure	Medium but only in localised area
Is site suitable for solar panels	Yes, on flatter area to the north

Is site suitable for infrastructure	Yes, on flatter area to the north
OVERALL MINING RISK	LOW with isolated areas of MEDIUM

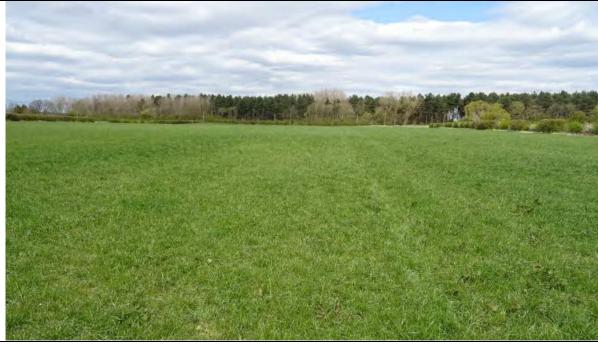
Area 1/8 looking North

Site Location	Area 1/8, 9, 10,
Current Use	Agriculture - arable
Slope	Mainly flat lying over entire site
Soil type	Slightly clayey soils
Geology	Triassic calcareous mudstones of the Barnstone Member, overlying the Cotham Member, the Westbury Formation and the Blue Anchor Formation (gypsum)
Depth to bedrock	2-3m
Existing constraints	Localised subsidence
Services	Buried oil pipeline 1/9 and telecommunications mast 1/8
Evidence of Historic Mine Workings	Kingston Mine entrance to west
Depth to workings	60-65m
Age of workings	1900-1940, younger workings in east of site 1980-1985 (1/12)
Mining Void	2.5 m maximum
Void to Rock Ratio	>10:1
Type of Workings	Pillar and Room irregular design except for small area of younger workings in extreme east with a regular mine layout
Evidence of subsidence	Localised areas evident as identified in Crown Hole and Subsidence Plan
Mining Risk to Solar Farm	Medium however low potential risk over larger area

Mining Risk to Infrastructure	Medium however low potential risk over larger area
Is site suitable for solar panels	Yes, on flatter area to the north, however subsidence risk should be noted
Is site suitable for infrastructure	Yes, on flatter area to the north
OVERALL MINING RISK	LOW with isolated areas of MEDIUM

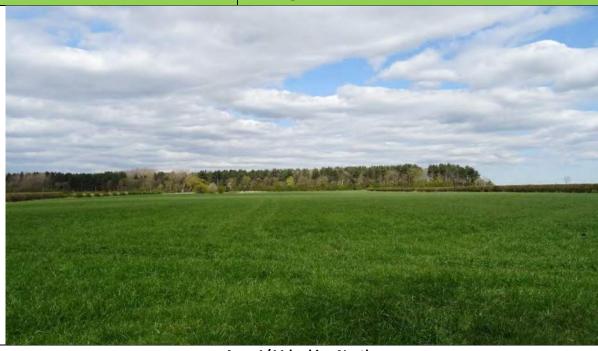
Area 1/11 looking North

Site Location	Area 1/11,12
Current Use	Agriculture - arable
Slope	Mainly flat lying over entire site
Soil type	Slightly clayey soils
Geology	Triassic calcareous mudstones of the Barnstone Member,
	overlying the Cotham Member, the Westbury Formation
	and the Blue Anchor Formation (gypsum)
Depth to bedrock	2-3m
Existing constraints	Localised subsidence
Services	Buried oil pipeline 1/9 and telecommunications mast 1/8
Evidence of Historic Mine Workings	Kingston Mine entrance to west
Depth to workings	60-65m
Age of workings	1900-1940, younger workings in east of site 1980-1985
	(1/12)
Mining Void	2.5 m maximum
Void to Rock Ratio	>10:1
Type of Workings	Pillar and Room irregular design except for small area of
	younger workings in extreme east with a regular mine
	layout
Evidence of subsidence	Localised areas evident as identified in Crown Hole and
	Subsidence Plan
Mining Risk to Solar Farm	Medium however low potential risk over larger area

Mining Risk to Infrastructure	Medium however low potential risk over larger area
Is site suitable for solar panels	Yes, on flatter area to the north, however subsidence risk
	should be noted
Is site suitable for infrastructure	Yes, on flatter area to the north
OVERALL MINING RISK	NO RISK TO LOW with isolated areas of
	MEDIUM

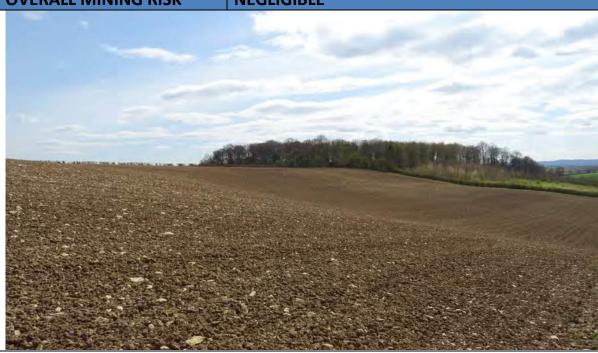
Area 2/2 looking South

Site Location	Area 2/2
Current Use	Agriculture - arable
Slope	Sloping to southwest over entire site (>10%)
Soil type	Slightly clayey soils
Geology	Glacial Till overlying Triassic calcareous mudstones of the Barnstone Member, overlying the Cotham Member, the Westbury Formation and the Blue Anchor Formation (gypsum)
Depth to bedrock	2-3m
Existing constraints	Slope
Services	None
Evidence of Historic Mine Workings	None
Depth to workings	>50m
Age of workings	1980-85
Mining Void	2.5 m maximum
Void to Rock Ratio	>10:1
Type of Workings	Pillar and Room regular design
Evidence of subsidence	None
Mining Risk to Solar Farm	Negligible
Mining Risk to Infrastructure	Negligible
Is site suitable for solar panels	Yes, on flatter area to the north but limited in extent due to slope
Is site suitable for infrastructure	Yes, on flatter area to the north but limited in extent due to slope
OVERALL MINING RISK	NEGLIGIBLE

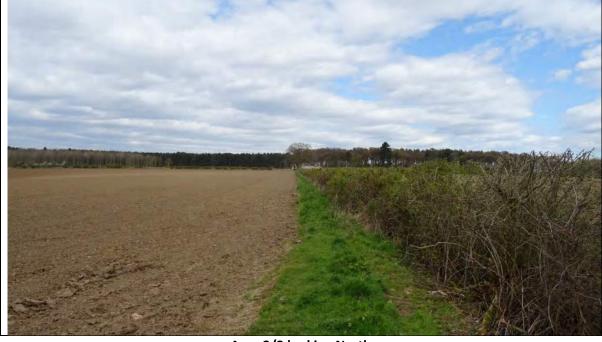
Area 2/3 looking North

Site Location	Area 2/3
Current Use	Agriculture - arable
Slope	Sloping to east over entire site (<10%)
Soil type	Slightly clayey soils
Geology	Glacial Till overlying Triassic calcareous mudstones of the Barnstone Member, overlying the Cotham Member, the Westbury Formation and the Blue Anchor Formation (gypsum)
Depth to bedrock	2-3m
Existing constraints	None
Services	None
Evidence of Historic Mine Workings	None
Depth to workings	>50m
Age of workings	1980-85
Mining Void	2.5 m maximum
Void to Rock Ratio	>10:1
Type of Workings	Pillar and Room regular design
Evidence of subsidence	None
Mining Risk to Solar Farm	Negligible
Mining Risk to Infrastructure	Negligible
Is site suitable for solar panels	Yes, on flatter area to the north but limited in extent due to slope
Is site suitable for infrastructure	Yes, on flatter area to the north but limited in extent due to slope
OVERALL MINING RISK	NEGLIGIBLE

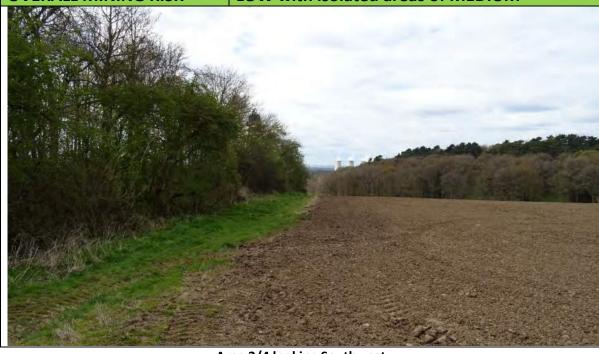
Area 2/4 looking Southwest

Site Location	Area 2/4
Current Use	Agriculture - arable
Slope	Sloping to south over entire site
Soil type	Slightly clayey soils
Geology	Glacial Till overlying Triassic calcareous mudstones of the
	Barnstone Member, overlying the Cotham Member, the
	Westbury Formation and the Blue Anchor Formation
	(gypsum)
Depth to bedrock	2-3m
Existing constraints	None
Services	None
Evidence of Historic Mine Workings	None
Depth to workings	>5m
Age of workings	1980-85
Mining Void	2.5 m maximum
Void to Rock Ratio	>10:1
Type of Workings	Pillar and Room regular design
Evidence of subsidence	None
Mining Risk to Solar Farm	Low
Mining Risk to Infrastructure	Low
Is site suitable for solar panels	Yes, on flatter area to the north but limited in extent due to
	steep slope
Is site suitable for infrastructure	Yes, on flatter area to the north but limited in extent due to
	steep slope
OVERALL MINING RISK	LOW with isolated areas of MEDIUM

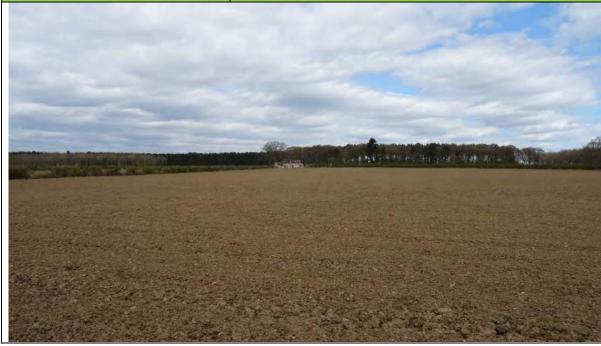
Area 2/5 looking North

Site Location	Area 2/5
Current Use	Agriculture - arable
Slope	Sloping to south over entire site
Soil type	Slightly clayey soils
Geology	Glacial Till overlying Triassic calcareous mudstones of the
	Barnstone Member, overlying the Cotham Member, the
	Westbury Formation and the Blue Anchor Formation
	(gypsum)
Depth to bedrock	2-3m
Existing constraints	None
Services	None
Evidence of Historic Mine Workings	None
Depth to workings	60-65m
Age of workings	1980-85, with older workings to northeast 1940-1960
Mining Void	2.5 m maximum
Void to Rock Ratio	>10:1
Type of Workings	Pillar and Room regular design except for small area of
	older workings in extreme east with an irregular mine
	layout
Evidence of subsidence	None
Mining Risk to Solar Farm	Low
Mining Risk to Infrastructure	Low
Is site suitable for solar panels	Yes
Is site suitable for infrastructure	Yes
OVERALL MINING RISK	NEGLIGIBLE TO LOW

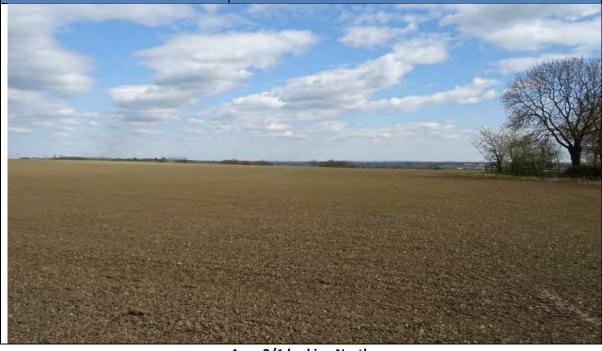
Area 3/1 looking North

Site Location	Area 3/1
Current Use	Agriculture - arable
Slope	Mainly flat lying over entire site
Soil type	Slightly clayey soils
Geology	Triassic calcareous mudstones of the Barnstone Member, overlying the Cotham Member, the Westbury Formation and the Blue Anchor Formation (gypsum)
Depth to bedrock	2-3m
Existing constraints	Slope to the southeast very gentle
Services	None
Evidence of Historic Mine Workings	Glebe Mine entrance to southeast of site
Depth to workings	60-65m
Age of workings	1975-1980
Mining Void	2.5 m maximum
Void to Rock Ratio	>10:1
Type of Workings	Pillar and Room regular design
Evidence of subsidence	None
Mining Risk to Solar Farm	Negligible
Mining Risk to Infrastructure	Negligible
Is site suitable for solar panels	Yes, on flat area
Is site suitable for infrastructure	Yes, on flat area
OVERALL MINING RISK	NO RISK TO NEGLIGIBLE

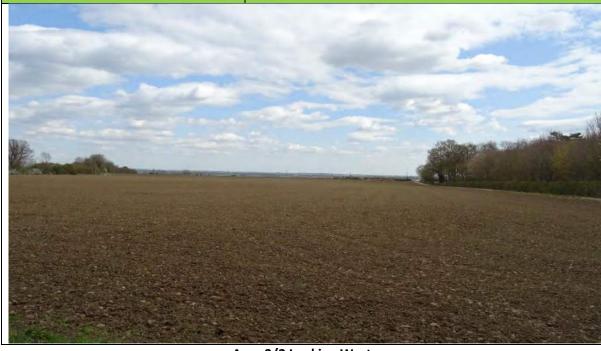
Area 3/2 Looking West

Site Location	Area 3/2
Current Use	Agriculture - arable
Slope	Mainly flat lying over entire site
Soil type	Slightly clayey soils
Geology	Triassic calcareous mudstones of the Barnstone Member, overlying the Cotham Member, the Westbury Formation and the Blue Anchor Formation (gypsum)
Depth to bedrock	2-3m
Existing constraints	Slope to the southeast very gentle
Services	None
Evidence of Historic Mine Workings	Glebe Mine entrance to southeast of site
Depth to workings	60-65m
Age of workings	1940-1960
Mining Void	2.5 m maximum
Void to Rock Ratio	>10:1
Type of Workings	Pillar and Room regular design
Evidence of subsidence	None
Mining Risk to Solar Farm	Low
Mining Risk to Infrastructure	Low
Is site suitable for solar panels	Yes, on flat area
Is site suitable for infrastructure	Yes, on flat area
OVERALL MINING RISK	NO RISK TO NEGLIGIBLE TO LOW
